Manhole Inspection Summary

Manhole # S47MM_019MH

Location Address: **Collington Ave**

Cross Street: **North Ave**

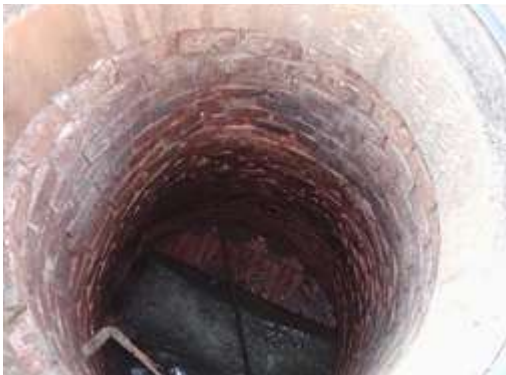
Defect 2

Infiltration: ☐ None ☒ **Joint** ☐ Cracks ☒ **Mortar** ☐ Roots ☐ Wall

Infiltration: ☐ None ☐ Joint ☐ Cracks ☐ Mortar ☐ Roots ☒ **Wall**

Infiltration

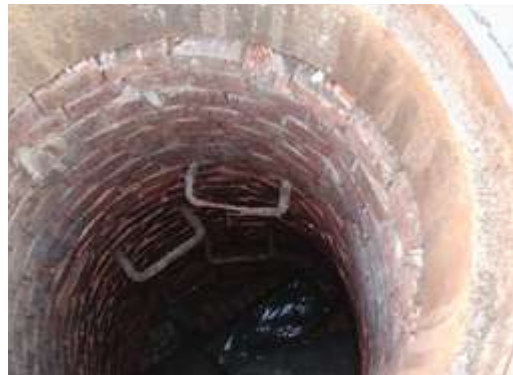
Defect 1

Condition: ☐ Sound ☐ Cracked ☐ Root Intrusion ☒ **Loose Brick** ☐ Deteriorated

Loose bricks

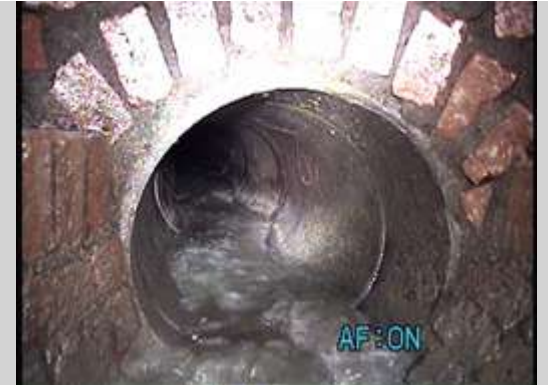
12 O'Clock Outflow

18 in. Circular Gravity Sewer
Pipe Out @ 12 O'Clock

Pipe Height: **18** (in.) Rod and Bar (Angled)
Pipe Material: **Clay** ☐ Pipe Lined
Invert Depth: **10.20** (ft.) Flow Characteristics: **Fast**
Deposits: ☒ None ☐ Mud ☐ Sludge ☐ Debris ☐ Grease
Silt Depth: (in.) Deposits Extent:
Infiltration: **None** Pipe Seal Cond: **Sound**

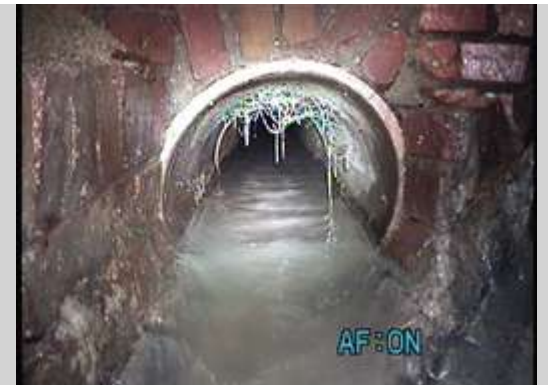
5 O'Clock Inflow

12 in. Circular Gravity Sewer
Pipe In @ 5 O'Clock

Pipe Height: **12** (in.) Rod and Bar (Angled)
Pipe Material: **Clay** ☐ Pipe Lined
Invert Depth: **10.00** (ft.) Flow Characteristics: **Fast**
Deposits: ☒ None ☐ Mud ☐ Sludge ☐ Debris ☐ Grease
Silt Depth: (in.) Deposits Extent:
Infiltration: **None** Pipe Seal Cond: **Sound**

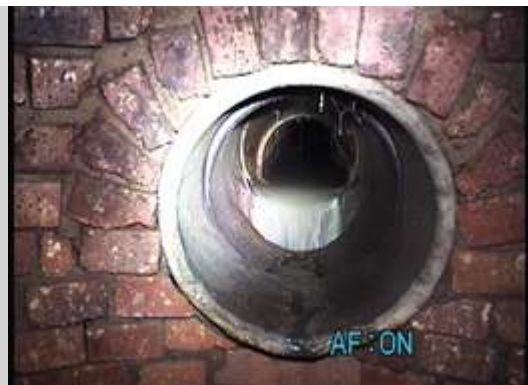
6 O'Clock Inflow

10 in. Circular Gravity Sewer
Pipe In @ 6 O'Clock

Pipe Height: **10.8** (in.) Rod and Bar (Angled)
Pipe Material: **Clay** ☐ Pipe Lined
Invert Depth: **7.80** (ft.) Flow Characteristics: **Fast**
Deposits: ☒ None ☐ Mud ☐ Sludge ☐ Debris ☐ Grease
Silt Depth: (in.) Deposits Extent:
Infiltration: **None** Pipe Seal Cond: **Sound**

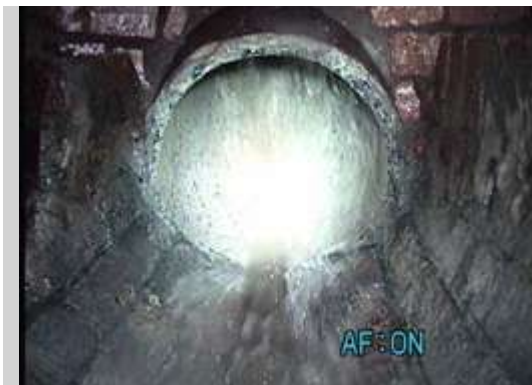
Drop In @ 6 O'Clock

Drop: Inside	Rod and Bar
Angled: Yes	Reading: 9.05 (ft.)
	Inv Depth: 10.05 (ft.)
Drop Condition: Open
